2012 Environmental Paper Award
HKIE Environmental Division

The Comprehensive Structural Investigation Programme – A Green Initiative for Building Sustainability

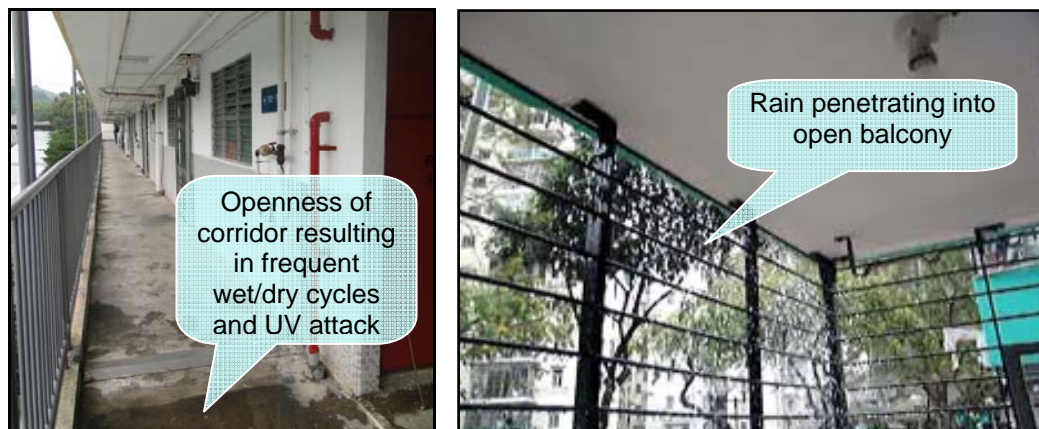
Figure 2: Exposed Elements in Aged Public Housing

formed the basis of the Hong Kong Building Regulations. Though British Code CP110:1972[7] introduced four environmental exposure classes in the 70s, the concrete cover and concrete strength requirements in Hong Kong had not increased until the introduction of the 1990 version of the Building Regulations [8, 9]. As a result, domestic buildings in Hong Kong built before 1990 typically specified Grade 20 concrete and 15 to 20 mm concrete cover for internal elements. Due to the lower concrete grade and inadequate cover, the older public housing buildings are today subject to a higher deterioration rate because of the vulnerability to ingress of water and contaminants. Moreover, exposed elements such as open staircases, balconies and cantilever corridors (Figure 2) common in the older buildings are constantly subject to frequent wet-dry cycles and UV attack. In addition, numerous moisture ingress paths are possible in the design and construction of toilet-cum-bathrooms without bathtub (Figure 3). Under these outdated design and construction conditions, quick-fix repairs would not be able to slow down the deterioration process, and the ensuing disturbing repetitive repairs would neither be cost-effective nor environmentally-friendly.

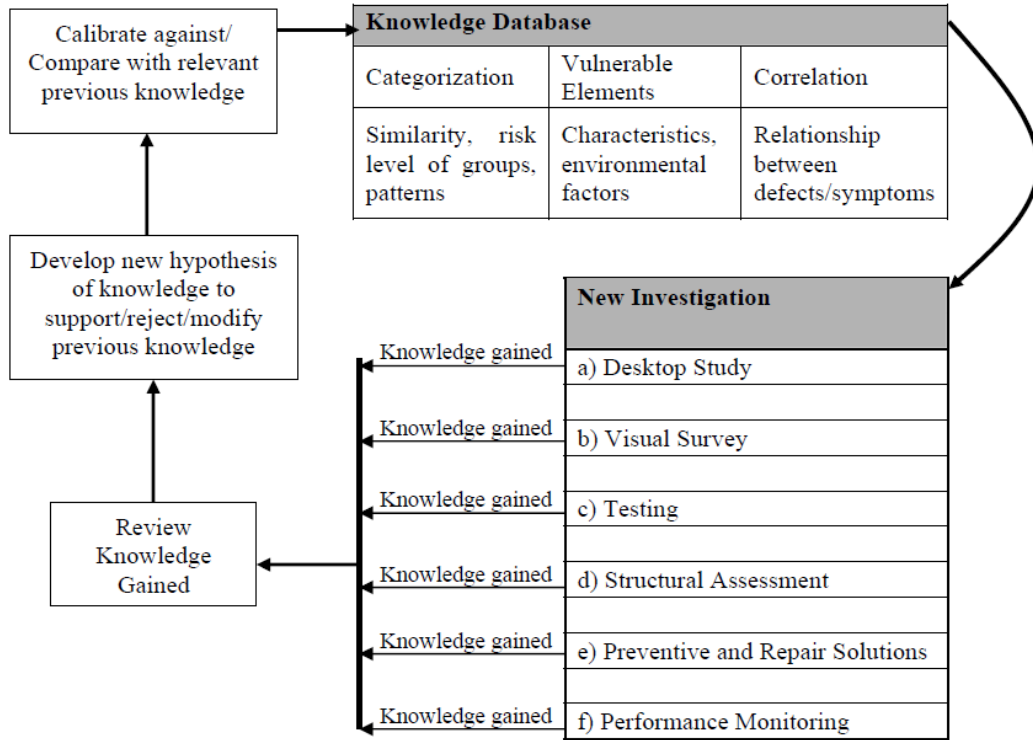
Figure 4: Knowledge Based Approach for the CSIP

3.2 The CSIP serves to identify the in-depth structural conditions of the aged public housing buildings and develop solutions to further sustain them for at least 15 years in an environmentally responsible manner. The CSIP adopts a knowledge based approach using the concepts of ISO 15686-1:2000(E) “Buildings and Constructed Assets – Service Life Planning – Part 1: General Principles” [10]. Due to the fact that the public housing of the HKHA comprises mainly standard buildings constructed on a repetitive basis, experience and findings obtained from the investigation of one building may be extended to similar buildings after thorough consideration and statistical analysis. The knowledge database mainly provides information in three areas (Figure 4), namely, the categorization of elements with similar risk levels or defective patterns, the characteristics of vulnerable elements, and the correlation between defects and service conditions / symptoms. The knowledge gained from a new investigation would be reviewed and calibrated against those in the knowledge database. Where necessary, the knowledge database could be updated for subsequent applications.

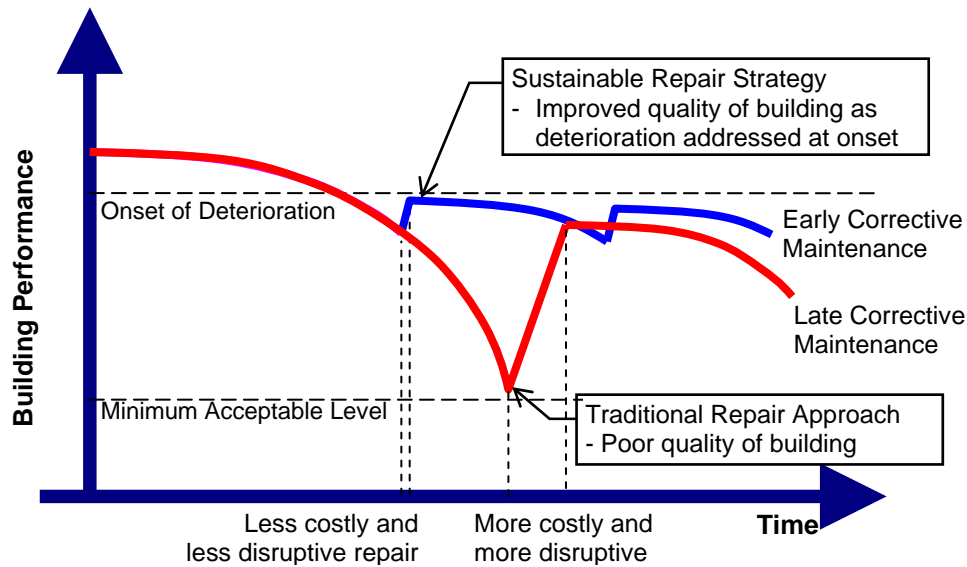
Figure 5: Sustainable Repair Strategy of CSIP vs Traditional Repair Approach

4.1 While there is an implicit idea of trade-offs amongst the environmental, economical, and social aspects of sustainability, the HKHA under the CSIP has formulated a number of repair and maintenance techniques that proved to be win-win-win solutions in all the aspects. The emphases (Figure 5) of the development and adaptation of repair solutions of the CSIP are to:

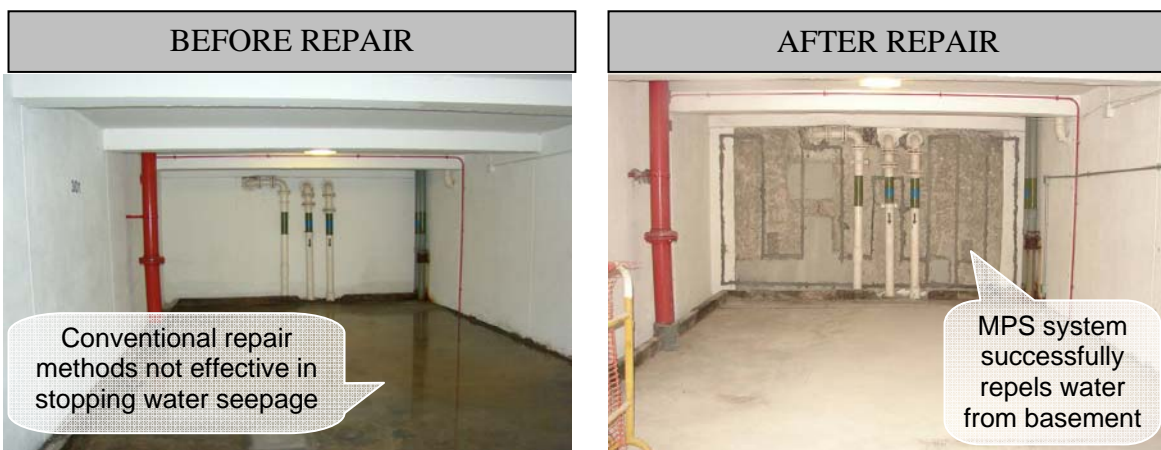
Figure 12: Basement Conditions before and after the Installation of the MPS system

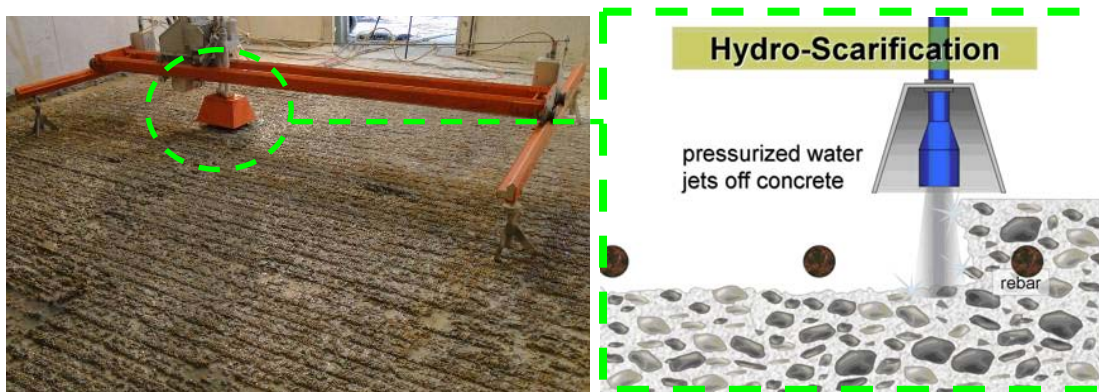
Figure 16: Concrete Removal by Automatic Hydro-Scarification Machine

(Figure 15) may cause micro cracks in concrete and damage existing reinforcement in the process [17, 18]. Moreover, the dust, noise, and vibration generated by jack hammering would be a major nuisance to the tenants of the entire building. As a result, hydro-scarification machines, which achieve the concrete destructive action by means of water pressurisation of cracks and cavitations in an automatic manner (Figure 16), were developed under the CSIP. The major advantages of the hydro-scarification machine in concrete removal are:

- No micro crack induced in concrete
- No damage to reinforcement
- Resulting in a sound exposed concrete surface with a good mechanical key
- Reduction in structural-borne sound and vibration
- Reduction in dust during concrete breaking
- Flexibility in concrete removal depth by adjusting the water pressure

To suit the site constraints in the public housing buildings, the original hydro-scarification machine developed under the CSIP was enhanced to facilitate transportation, access, and application. Further green initiatives in reusing wastewater and recycling aggregates arising from the hydro-scarification work are being undertaken. The concrete removal technique was successfully employed in several existing public housing estates with encouraging feedback from the tenants and stakeholders. Besides being widely used in the HKHA projects, the HKHA has been striving to introduce the hydro-scarification technique to the building industry including both public and private sectors, with a view of turning the hazardous and disturbing concrete removal task to a safe and environmentally-friendly operation.

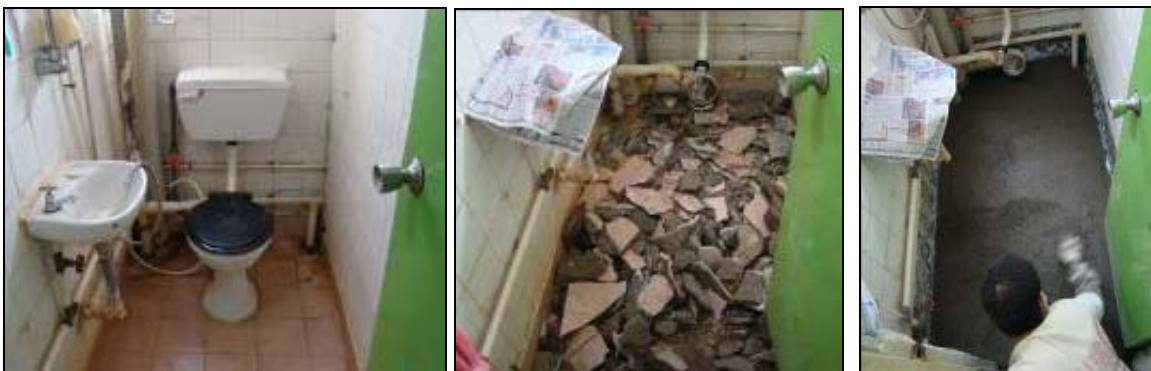
Figure 17: Time Consuming and Disturbing Conventional Re-waterproofing

existing floor finishing, re-waterproofing and subsequent reinstatement (Figure 17). Not only does this 3-day repair work represent a major nuisance to the tenants, the work is detrimental to the environment as the entire existing floor finishing is turned into construction waste. Another drawback is that the work can only be done properly at difficult areas with particular attention (Figure 18), such as the areas near congested pipes and floor drains, resulting in less satisfactory long-term performance. In addition, the demolition work in conventional re-waterproofing systems may cause possible damage to the existing structure. In view of the drawbacks and difficulties, an alternative approach of using the polyurea waterproofing system (PWS) was introduced under the CSIP to solve the current difficulties. The PWS possesses the properties of rapid setting, high hardness, high flexibility, high tear strength, high tensile strength, and good resistance to chemicals, weathering and abrasion. The attributes of polyurea together with its spray-on application enable it to become a seamless, effective and durable waterproofing system (Figure 19). Based on the positive results (Table 2) from a comprehensive study on the environmental, social and economical performance of the PWS, the HKHA is considering applying this environmentally friendly solution to its existing buildings from 2013.

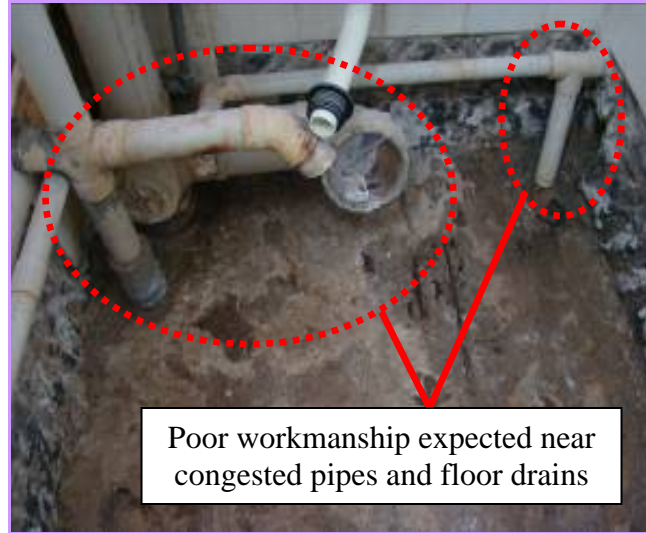
Figure 18: Problematic Areas for Conventional Waterproofing System

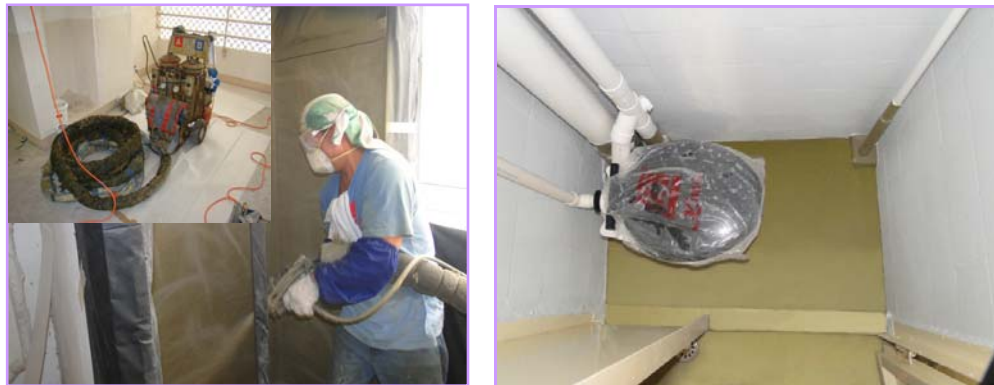
Figure 19: Spray-on PWS to Cope with Congested Areas

Environmentally Friendly	<ul style="list-style-type: none"> ✓ No need to remove existing tiles, screeding ✓ Minimal noise, dust, vibration
Tenant Oriented	<ul style="list-style-type: none"> ✓ 1 day of work for PWS vs 3 days of work for conventional method
More Durable	<ul style="list-style-type: none"> ✓ High water resistance ✓ High abrasion resistance ✓ High flexibility ✓ High chemical resistance ✓ Excellent adhesion to different substrate ✓ Seamless system covering difficult areas effectively
